DOT/FAA/W/92-1  
DOT-VNTSC-FAA-92-6

## 1991 LLWAS Anemometer Test Program

Final Report  
September 1992

U.S. Department  
of Transportation  
Federal Aviation  
Administration

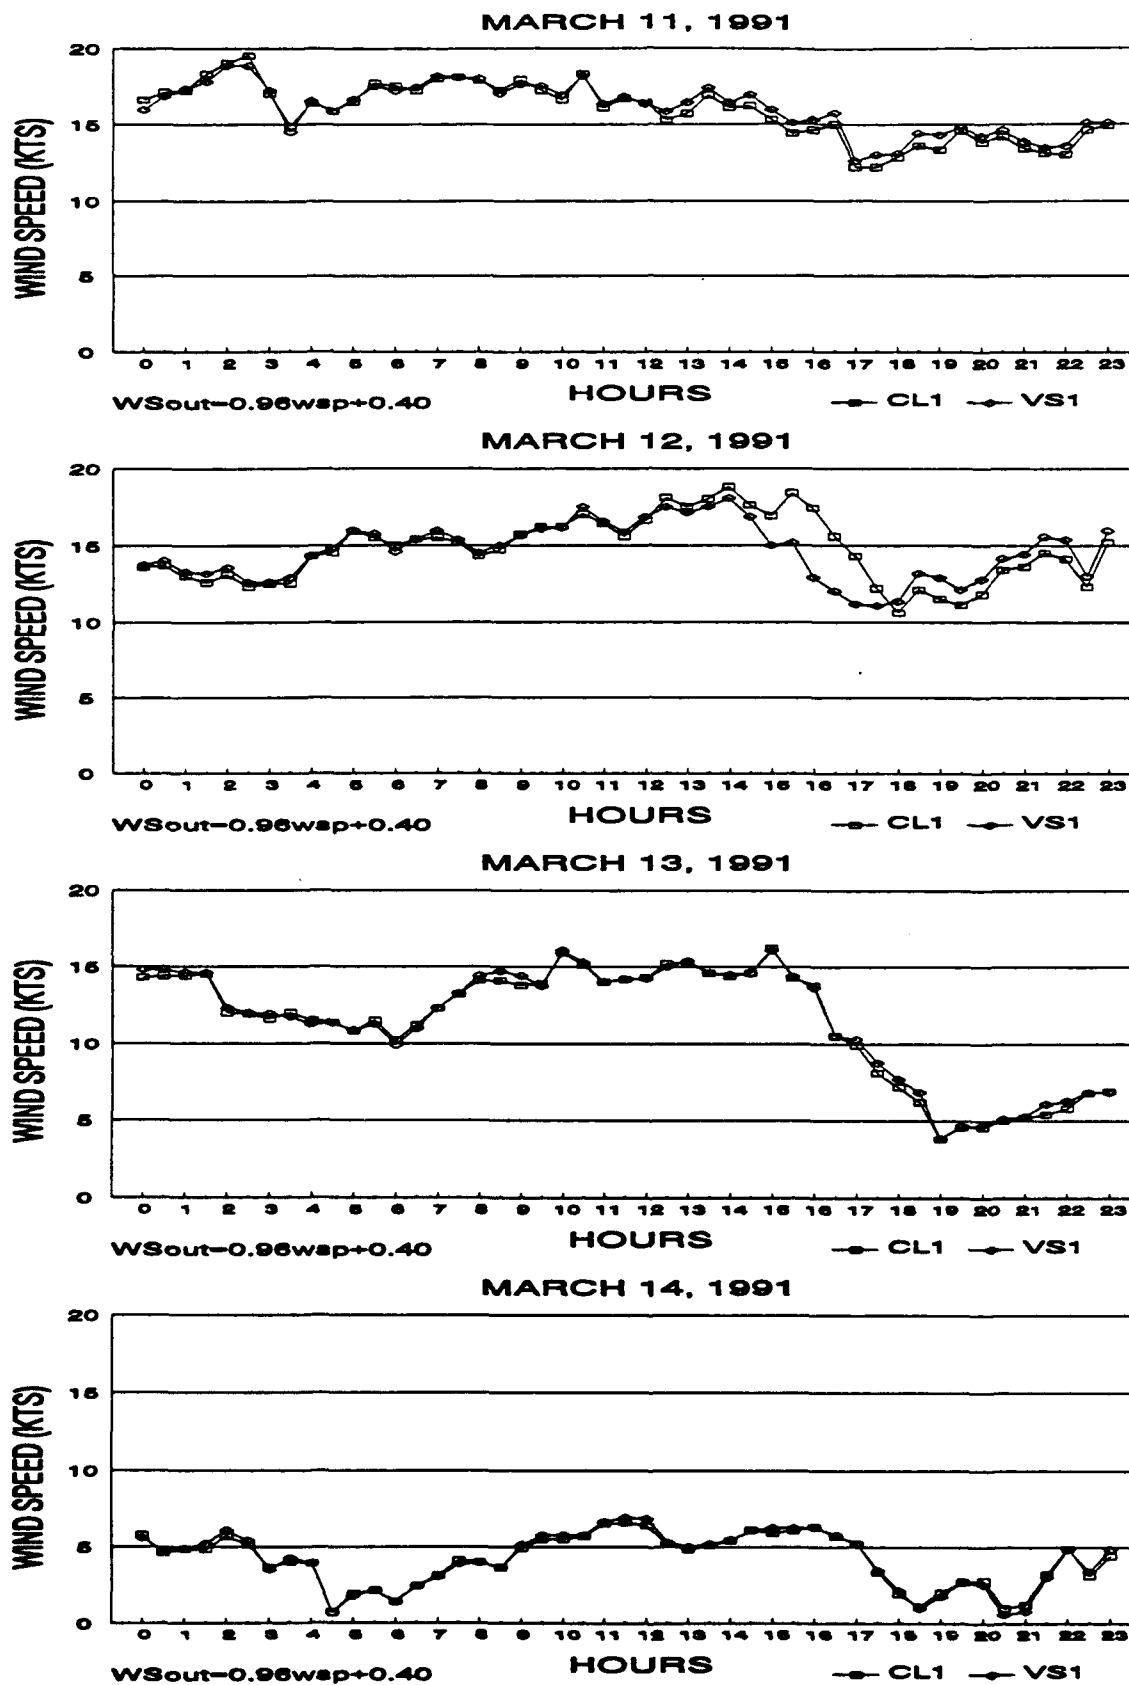
FIGURE 4-15. COMPARISON OF VS1 AND CL1 WIND SPEED ON 3/11-14/91

**4.4.3.3 3/12/91 Snow Event** - The March 12, 1991 snow event is an interesting case study because there is evidence of effects on the two Vaisala cup anemometers, probably due to blowing snow. The snow event follows the icing period in Section 4.4.3.2. The wind conditions were similar (Figure 4-12) and the same comments on the other sensors pertain.

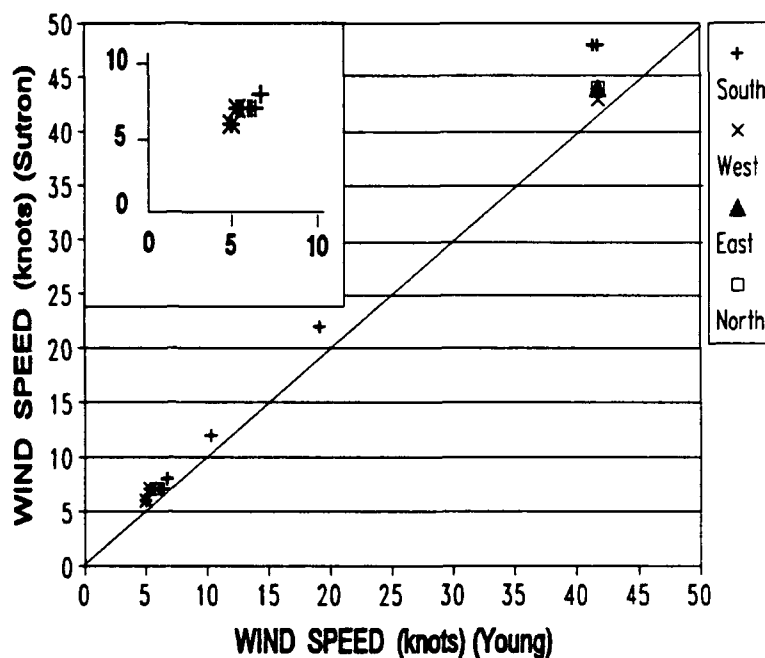
FIGURE 5-3. SUTRON CALIBRATION(S/N 90SC1)

The Sutron and Armtec field test readings of two knots higher than all the other sensors were substantiated for both sensors at low wind speed as shown in Figures 5-3 and 5-4.

Most of the Sutron data was for one direction (south). The Sutron sensor was reading almost 2 knots higher than the R.M. Young reference for winds below 15 knots. The error became larger for higher wind speeds, reaching an error of about 7 knots at a reading of 42 knots. The spread in calibration for different directions at 42 knots was about 5 knots.

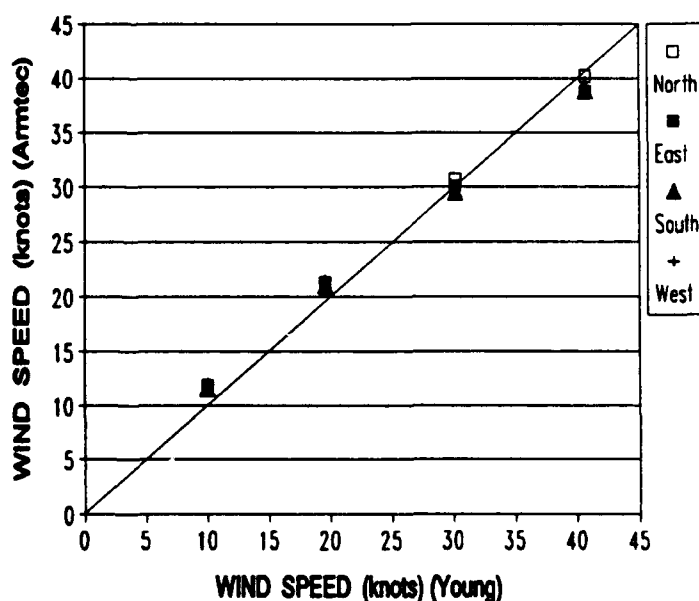
FIGURE 5-4. ARMTEC CALIBRATION (S/N 171)

At 10 knots, the Armtec sensor was also reading almost 2 knots higher than the R. M. Young reference sensor in all four directions. The Armtec sensor readings came into closer agreement with the R. M. Young sensor as the wind speed increased.

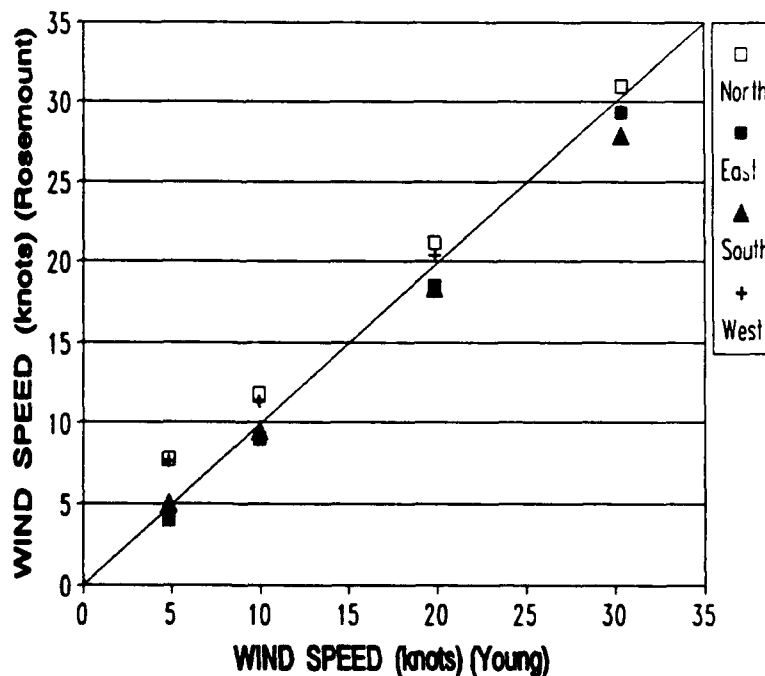
FIGURE 5-6. ROSEMOUNT CALIBRATION (S/N LLWAS1)

Figures 5-6 and 5-7 show the calibrations of the two Rosemount sensors. Four wind directions (north, east, south, and west) were tested for most wind speeds. RS1 (S/N LLWAS1) had been modified during the field testing to improve its response at low wind speeds. This modification limited RS1 to measuring wind speeds to a maximum of about 35 knots. RS2 (LLWAS2) was tested at wind speeds over the normal range (up to 42 knots).

Both Rosemount sensors showed somewhat greater differences from the R. M. Young reference sensor at low wind speeds than at high wind speeds, as would be expected for a pressure sensor. Since the signal is proportional to the square of the wind speed, a pressure offset will produce a greater error at lower wind speed. The modified RS1 sensor did show at best, a slight improvement in performance over the other Rosemount unit at the low wind speeds, but the improvement was at the cost of

reduced dynamic range. The Rosemount sensors also showed significant calibration variations (4 knots) with direction at both high and low wind speeds.

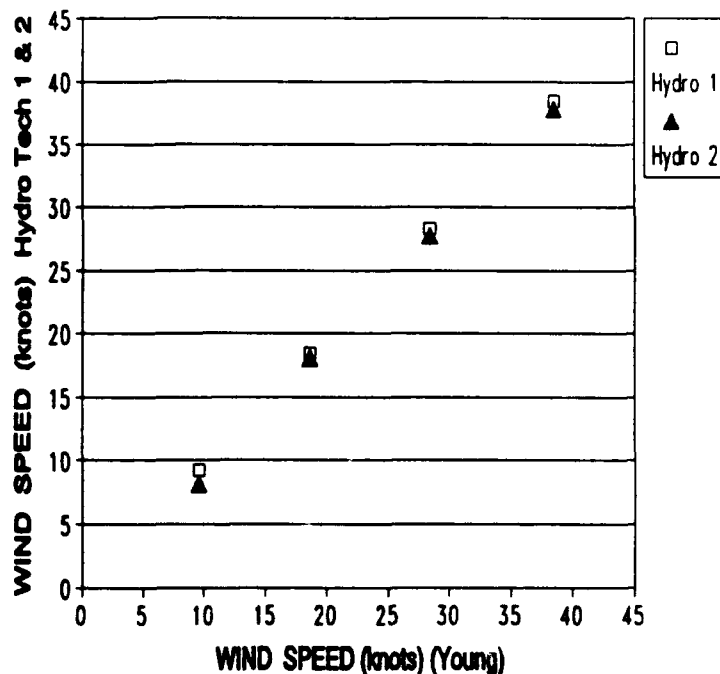
FIGURE 5-8. HYDROTECH CALIBRATIONS (S/N 131, 132)

Figure 5-8 shows the calibration for the two Hydro Tech anemometers. Their response was consistent at high speeds, but somewhat different at low speeds. This difference represents the high starting threshold noted in section 5.2.4.

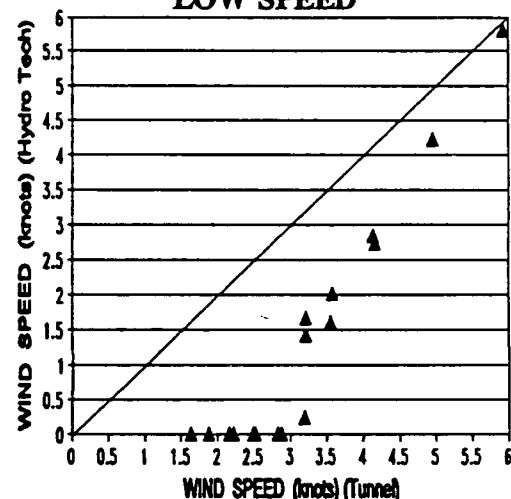
**FIGURE 5-13. HYDRO TECH:  
LOW SPEED**

The R. M. Young anemometer was indeed the most sensitive and had the lowest starting threshold. Climatronics, Vaisala, and Belfort (cup) had starting thresholds in close proximity to each other. The Hydro Tech anemometer had the highest starting threshold at about 3 knots. Note that this higher starting threshold results in significant measurement errors at wind speeds up to five knots. The second Hydro Tech anemometer was also tested for suspected problems. The starting threshold on the second Hydro Tech was somewhere between 5.5 and 7 knots, probably due to a bad bearing.
